TECHNICAL REPORT
TR-NAVFAC-EXWC-PW-1303
SEPTEMBER 2013

**BUILDING INTEGRATED PHOTOVOLTAIC (PV)
ROOFS FOR SUSTAINABILITY AND ENERGY
EFFICIENCY**

ESTCP Number: EW-200813

September 2013

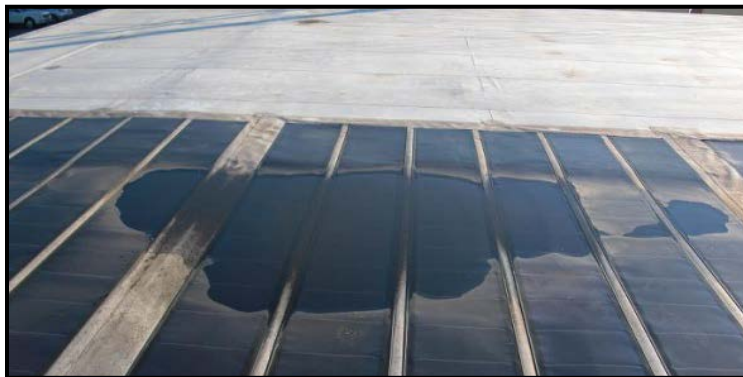
ROOFER EMS survey records for Site II (NAS Patuxent River) are shown Appendix H and the resulting condition indices are shown Table-5. The condition indices were significantly impacted by mold growth on the PVC and a warping dens-deck shown in Figure-28 and water ponding shown in Figure-29. Since mold growth was not present at either Site I (Luke AFB) or Site III (MCAS Yuma), it was once again determined to be worthwhile for the ROOFER survey team to measure the roof reflectance while they were on site (Table-6; Appendix I). Due to a lack of clear skies, a condition necessary for proper roof albedo measurement, only one measurement was acquired for Site II (NAS Patuxent River). In addition, it was impossible to properly measure the albedo of the PV modules due to water ponding. Water ponds also reduce the amount of sunlight the PV modules receive, thus, reduces the PV energy output.

Figure-29: Significant ponding at Site II (NAS Patuxent River).

water and the pool of water that is shown in Figure-29. There was a lack of snow events, so snow impacts could not be quantitatively determined, but it is expected that snow retention on the roof will significantly reduce the PV power output more than the water retention.

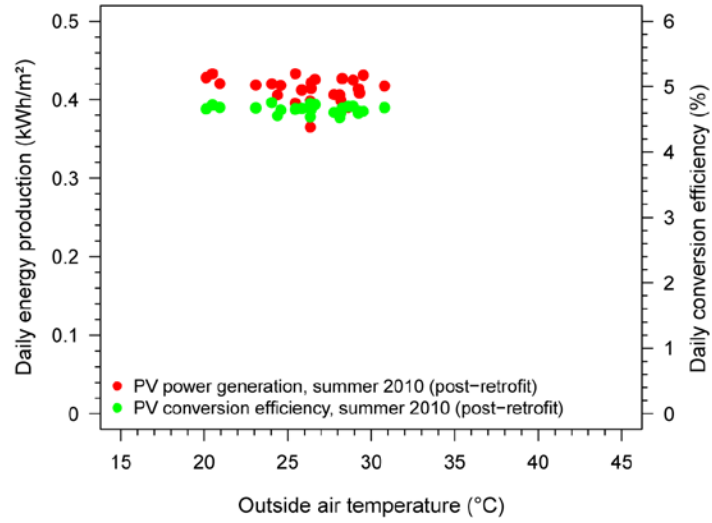
Figure-39: Daily PV energy production per unit PV surface area and mean PV conversion efficiency versus outside air temperature Site III (MCAS Yuma).

Looking at the energy generation and PV conversion efficiency under a smaller time-scale makes it easier to see how PV output performance correlates to outside air temperature, Figure-39 shows that both values are fairly constant, which shows that this type of PV module performs fairly well in hot, desert conditions.

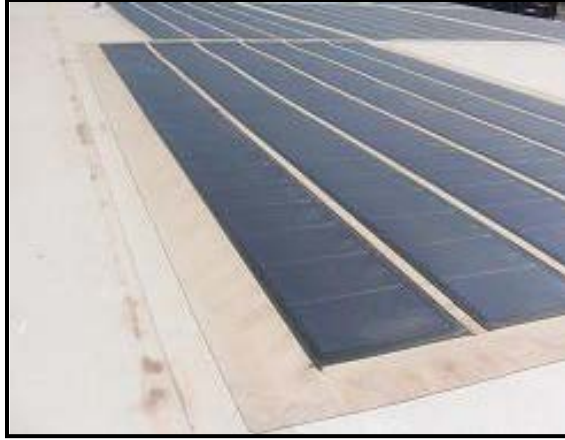
ROOFER results are shown in Table-7 (Appendix J). PV and PVC reflectance results are shown in Tables-8 and -9, respectively (Appendix K). The “with patch” indices are a result of the samples taken from the roof for the laboratory testing discussed later. ROOFER indices without the patch, as if the samples were not taken, were also generated for comparison. October 2011 reflectance values were not attained due to the removal of the ladder needed to safely transport the instrument onto the roof. Since soiling is the largest contributor to reflectivity, visible conditions indicated that the reflectance of the roof had improved in October 2011 when compared to December 2010. This determination is further supported by the PV conversion efficiency analysis, that will be presented in the next section, which shows atypically low efficiency values in Winter 2010. Despite the soiling, the Site III (MCAS Yuma) BIPV roof appeared to have aged the best when compared to the other two sites (Figure-42).

Figure-42: Photo of Site III (MCAS Yuma) in October 2011, 16 months after installation.

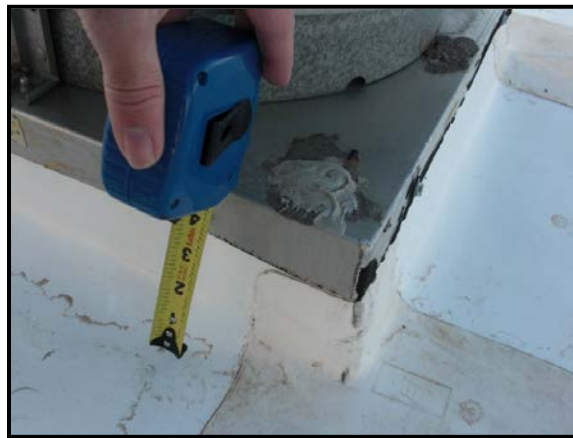
Figures-43 and -44 show the problem with the flashing not exceeding the six-inch height requirement, which reduced the overall FCI. The flashing height requirement is to prevent water penetrating the roof through rooftop equipment, such as exhaust vents.

Figure-43: Photo of Site III (MCAS Yuma) exhaust vent with insufficient flashing height.

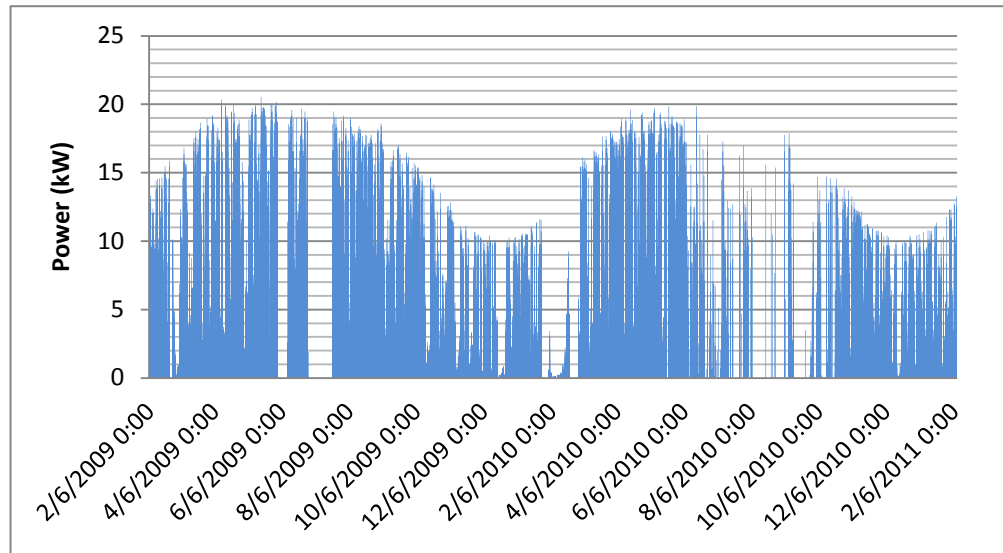
Over the course of the two (2) years of monitoring, the BIPV system produced a peak energy of 20.5 kilowatts, with an average of 6.6 kilowatts (See Figure 6). A total of 61,000 kilowatt-hours of energy was produced throughout the monitoring period. The BIPV is able to support an off-grid load of up to 20 kilowatts, but is best suited for a load of 5.31 kilowatts in that application.

The estimated system performance was 42,787 kWh and the actual system produced 30,500 kWh annually. Annually, the system underperformed design expectations by 28.72%. BIPV system was designed at 34.848 kWp DC. An actual 24.740kWp AC was recorded on July 19, 2010 at 3:00PM. At peak, the BIPV underperformed expectations by 29%. Based on these findings, the de-rating factor is actually 0.63 instead of 0.77. The de-rating factor is the combination de-rating factors that affect each component of the system. More study would be needed to determine which of these de-rating factors actually varied from design conditions.

Figure 6 Energy throughout Monitoring

There was no noticeable change in the performance between year one and year two. Periodic cleaning of the PV and additional monitoring could help determine actual preventive maintenance practices.
